Monitoring Data Record

Project Title: Twin Oaks (R-2302) COE Action ID: 199920857
Stream Name: Perennial stream flowing into the New River DWQ Number: 990491
City, County and other Location Information: Sta. 39+50 – 48+50 on US 21 S of Twin Oaks
Date Construction Completed: N/A Monitoring Year: (1) of 1
Ecoregion: _____ 8 digit HUC unit 05050001
USGS Quad Name and Coordinates: _____

Twin Oaks

1st Quarter – December 2003

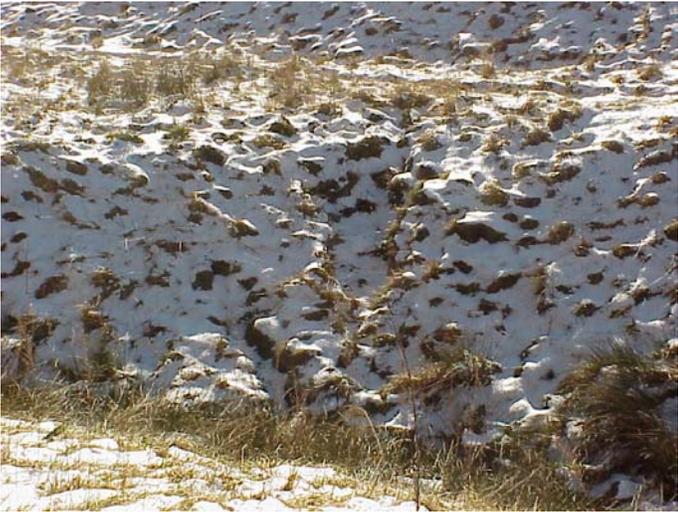
Other Information relative to site photo reference: Photo 9 documents a washed out area.

The stream is very stable and is doing well. One washed out area on the south side of the upper portion of the stream (Photo 9). Difficult to assess the extent of the erosion due to the snow. Silt fence in need of repair.
